# Survey of Submerged Cultural Resources in Northern Door County

1988 FIELD SEASON REPORT

DAVID J. COOPER ◦ UNDERWATER ARCHEOLOGY  
PROGRAM ◦ DIVISION OF HISTORIC PRESERVATION  
◦ STATE HISTORICAL SOCIETY OF WISCONSIN ◦

J U N E 1 9 8 9

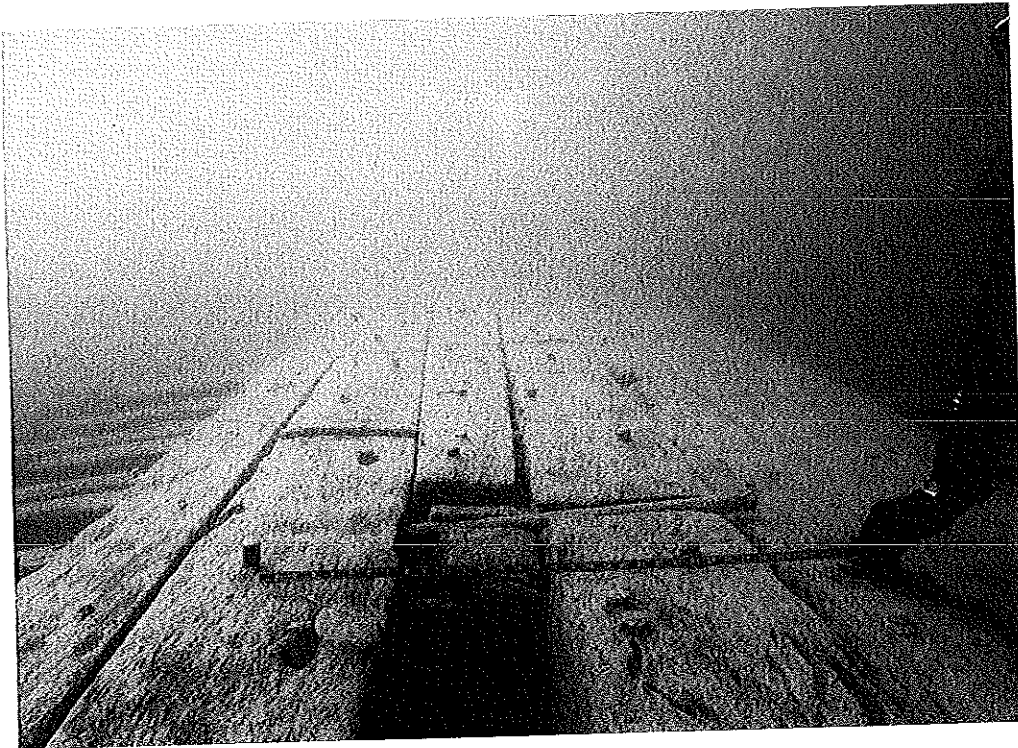
Figure 9. *Inverted bottom of A.P. NICHOLS; note centerboard trunk and flush keel.*

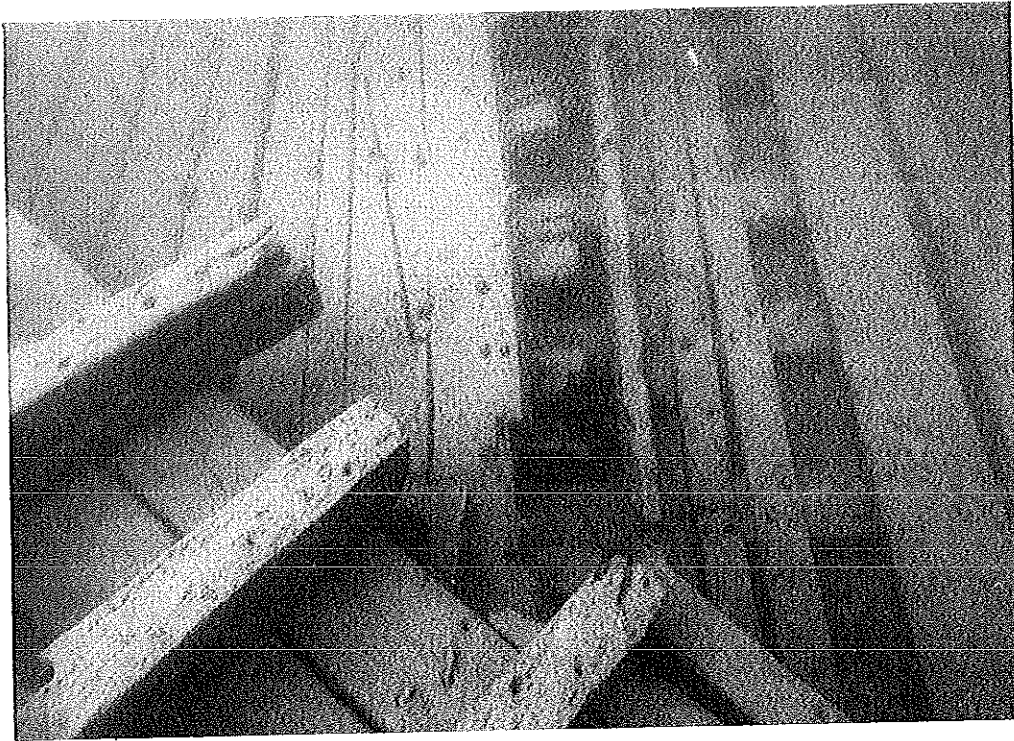
Figure 11. *Port side and rail of NICHOLS, overlain by inverted bottom.*

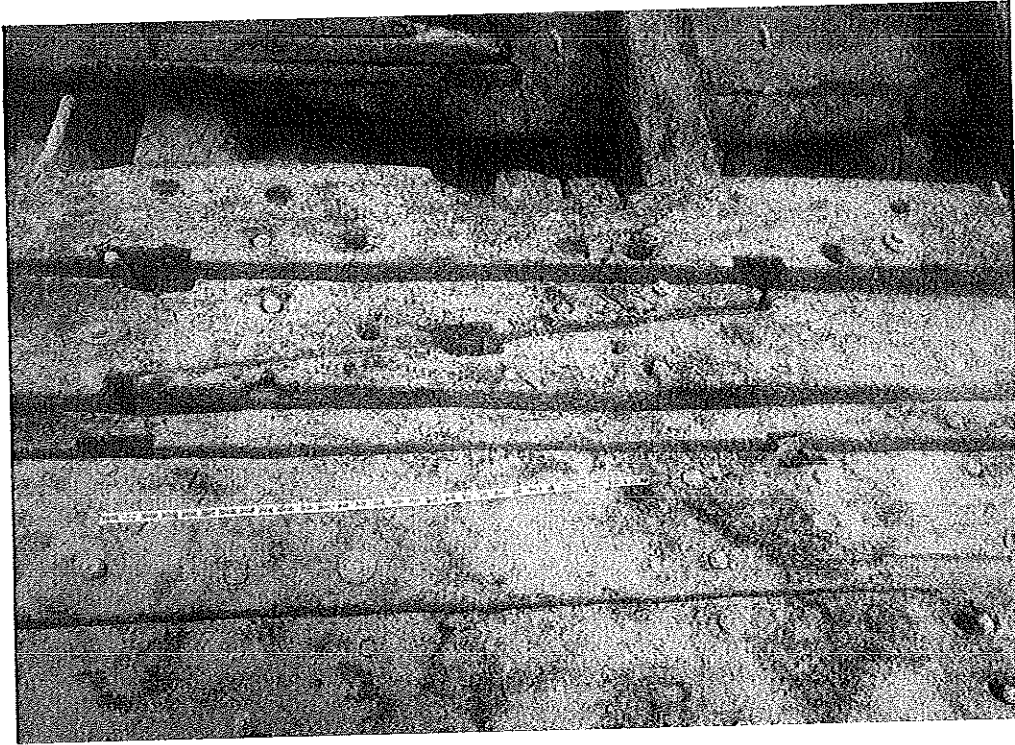
Figure 13. *Keyed scarphs, A.P. NICHOLS ceiling, section H.*

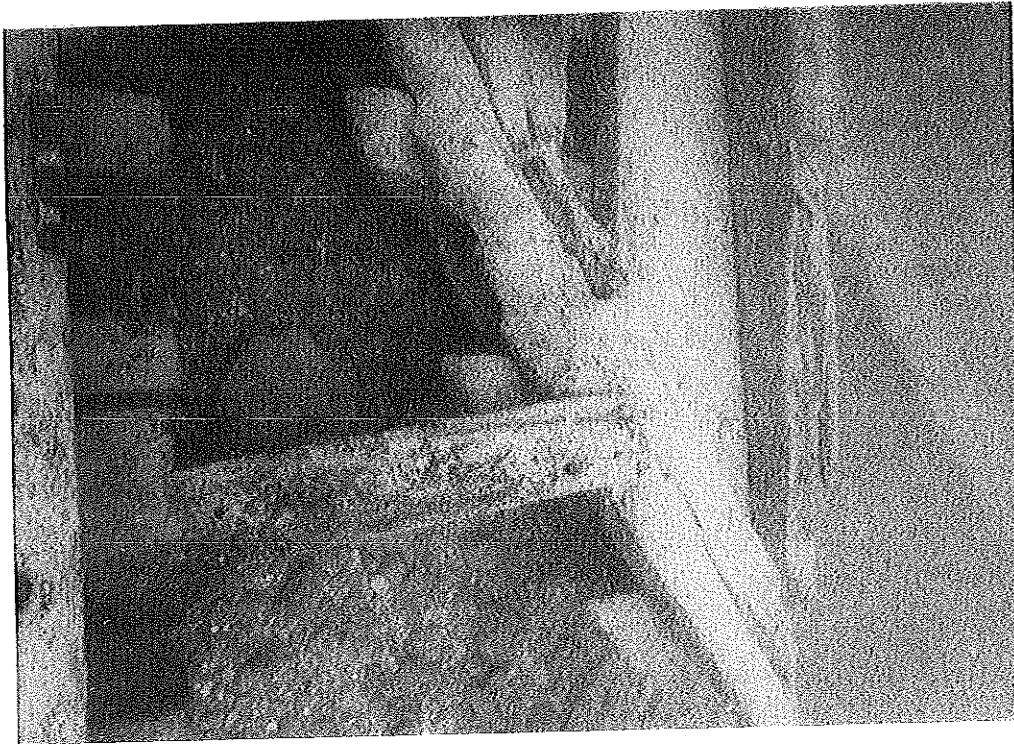
Underlying both C and H is section G, whose deposition obviously predates 1894 (the breakup of the NICHOLS). While this only eliminates the J.E. GILMORE and O.M. NELSON from the list of wreck candidates, diagnostic construction elements again provide evidence for its identity. G is a section of port side, bulwark, and port bow of a scow schooner, the identity of the latter being made from the characteristic scow bow construction exhibited at the southeastern terminus of the feature (Figure 14). Photographic evidence (Hirthe and Hirthe 1986:35) clearly shows the distinctive construction employed in scow bows, versus clipper bows or more conventional types of bow construction. The only known loss of a scow schooner at Pilot Island was a wreck closely associated with the loss of the NICHOLS; the scow schooner FOREST.

Figure 14. *Section G; scow bow construction, probably from FOREST.*

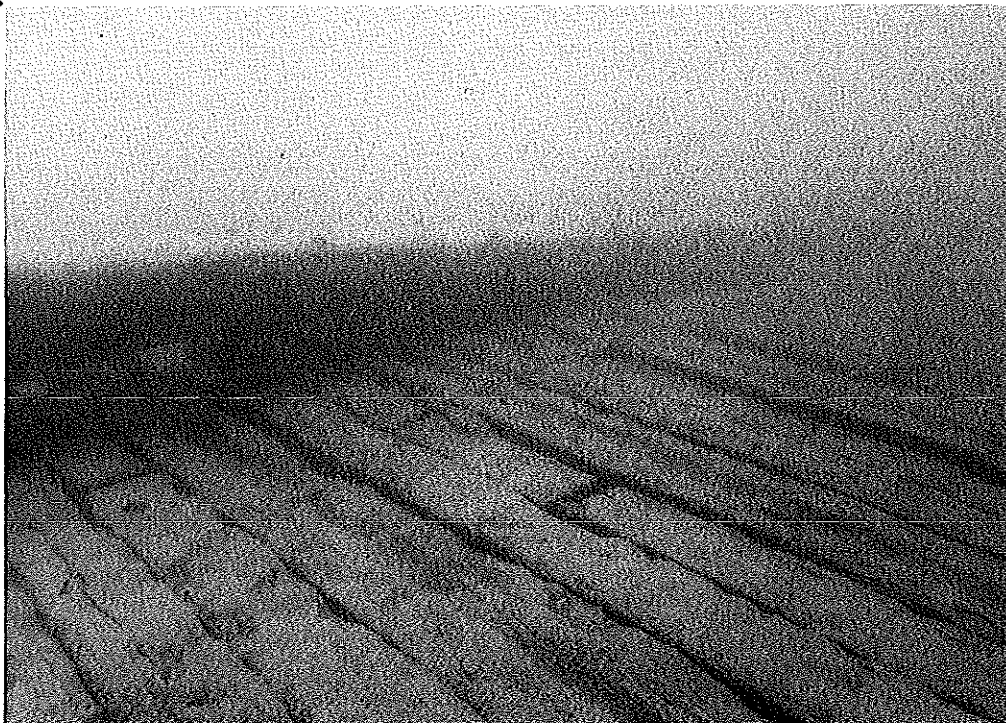
The surviving hull remains consist of almost solid floor framing overlain with multiple keelsons, evidence of this prototype bulk carrier's extensive longitudinal reinforcement. A single keelson sided 11" at the bow and 14"

Figure 16. *HACKETT floors and port bilge keelson; note close spacing of floors.*

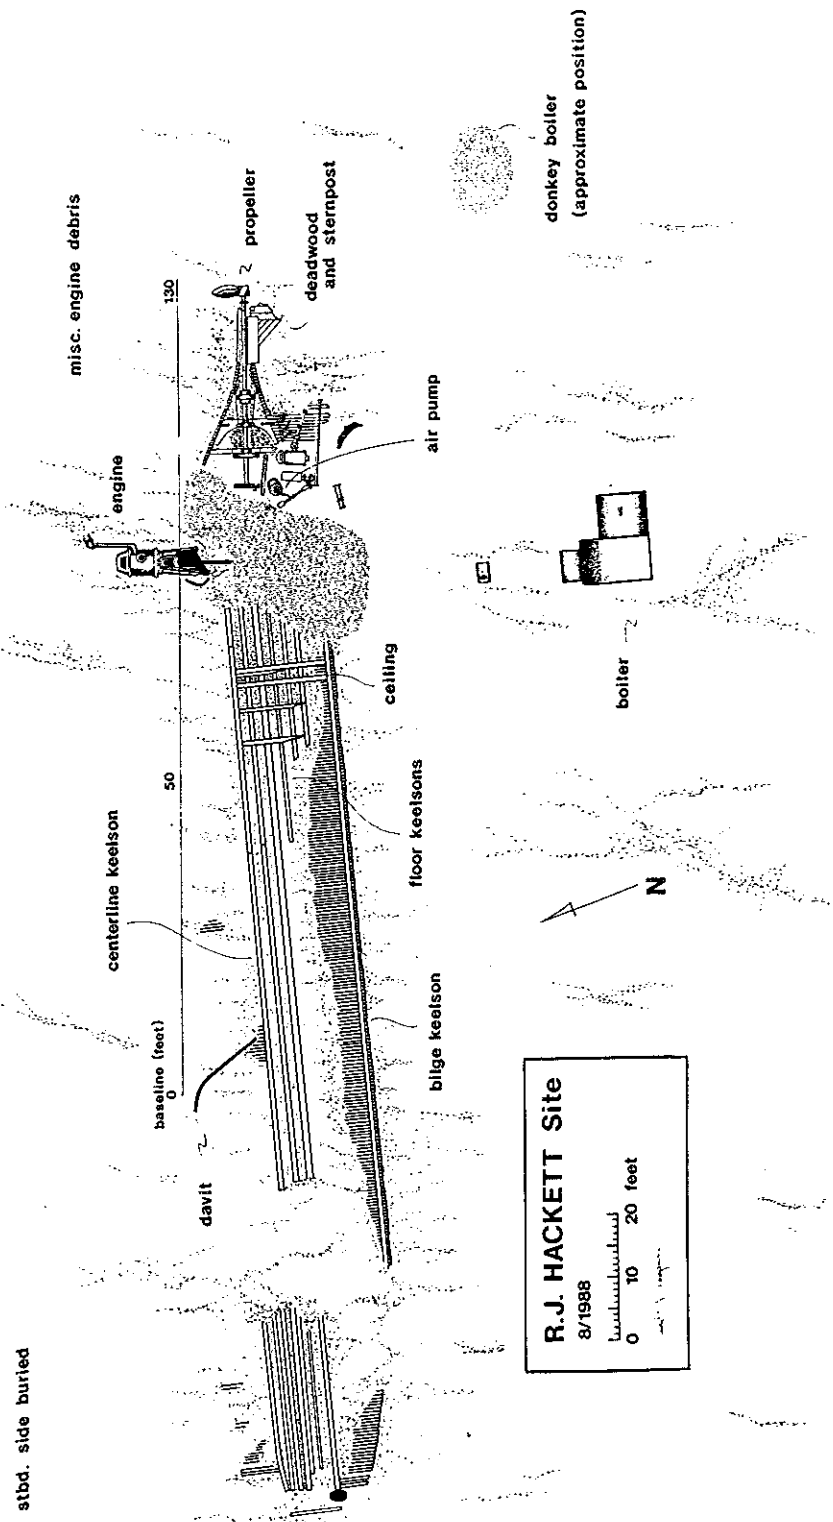
Figure 17.

The wreck lies on a gradual slope of sand and gravel, partially burying the site (Figure 17). An overall 190 foot length of the vessel is extant, running from the propeller forward, with approximately 145 feet of the port bilge exposed. The starboard side of the bilge is buried under approximately 6" to 15" of sand overburden, and is only intermittently exposed in random scour areas. The hull is intact to the turn of the bilges, beyond which it seems to have been destroyed by a combination of the original fire and later storms and ice movement. No evidence for the hull sides, decks, or superstructure was found on site, though there are reports of scattered wreckage over other areas of the shoal (Shastal, personal communication 1988). Visual survey by the 1988 team focused on documenting only the main wreckage area and machinery, leaving a survey of the entire shoal for future investigations.

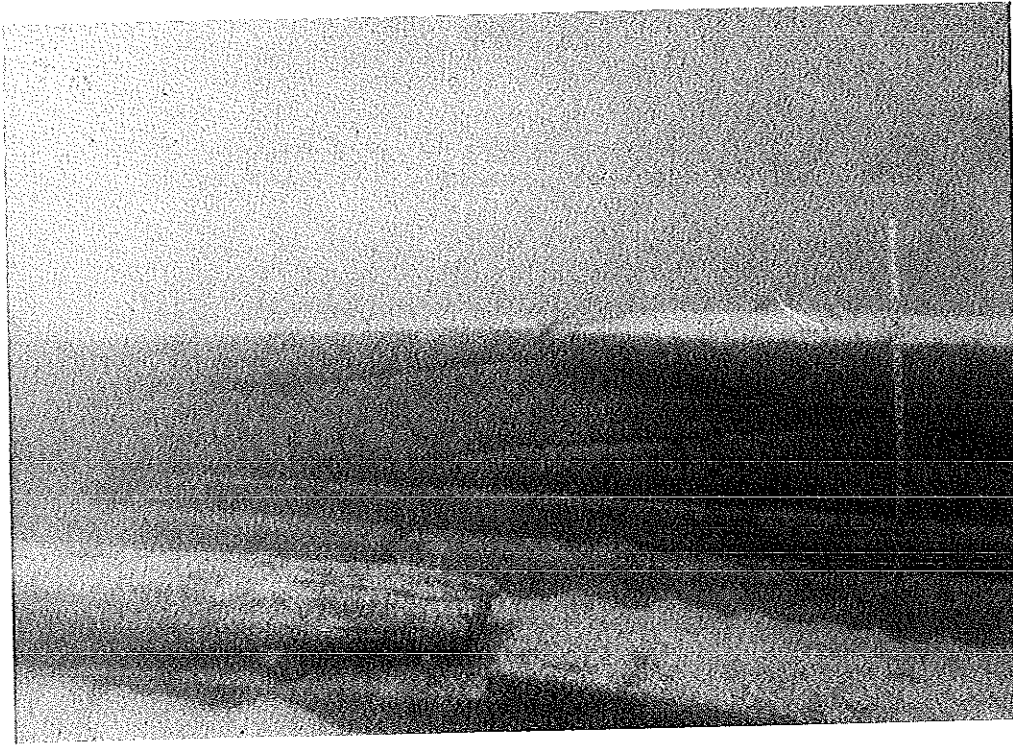
Figure 18. *Scarph joints in keelson and rider, amidships viewed from port side.*

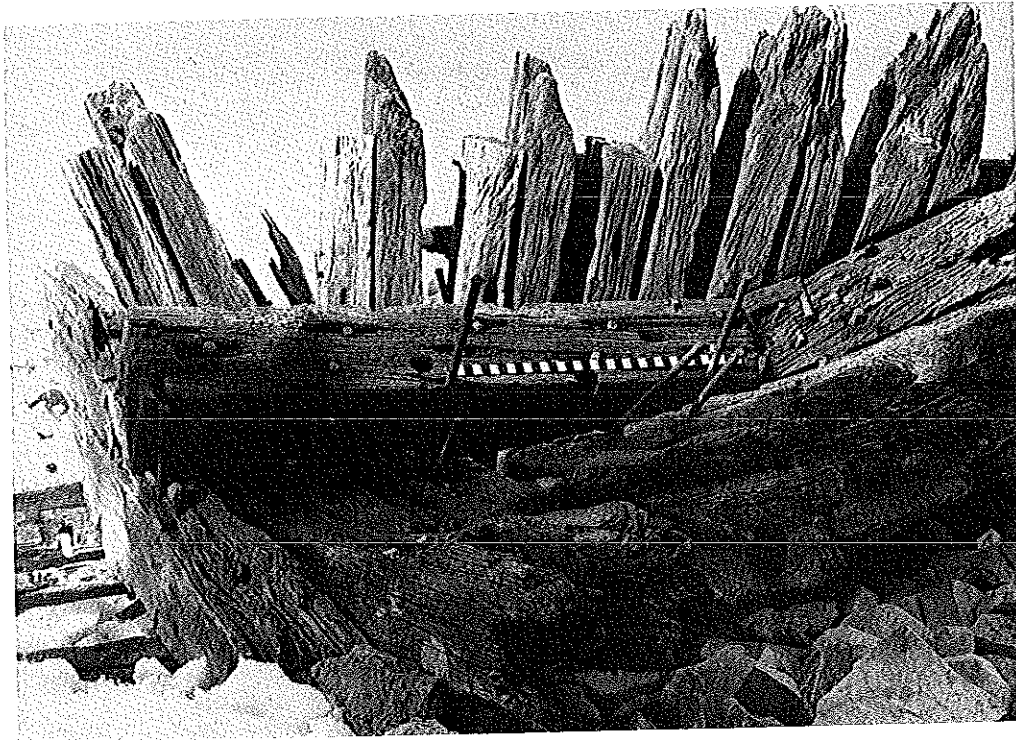
Figure 23. *Disarticulated bow section.*

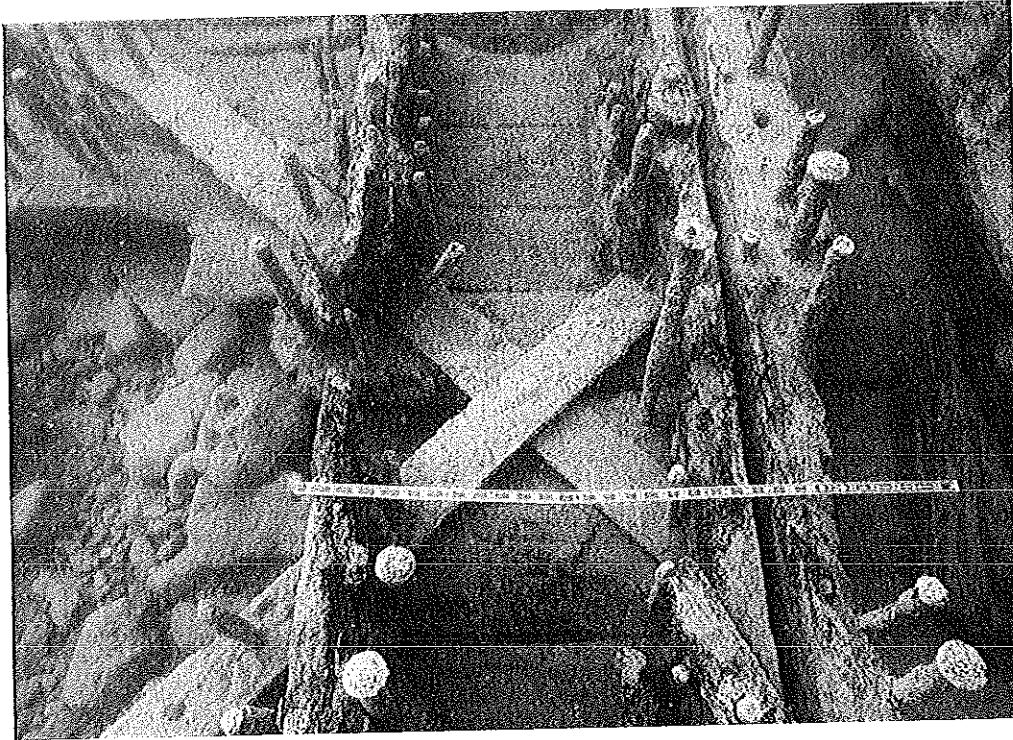
The hull of the LOUISIANA is constructed entirely of wood, with iron cross-bracing in her sides (Figure 25), and fastened with iron. The timbers appear to be of white oak (as was common practice), but wood sampling was not conducted by the researchers to ascertain the actual material used. Multiple keelsons were used for longitudinal strength, and the hold of the vessel was

Figure 25. *Iron cross-bracing.*

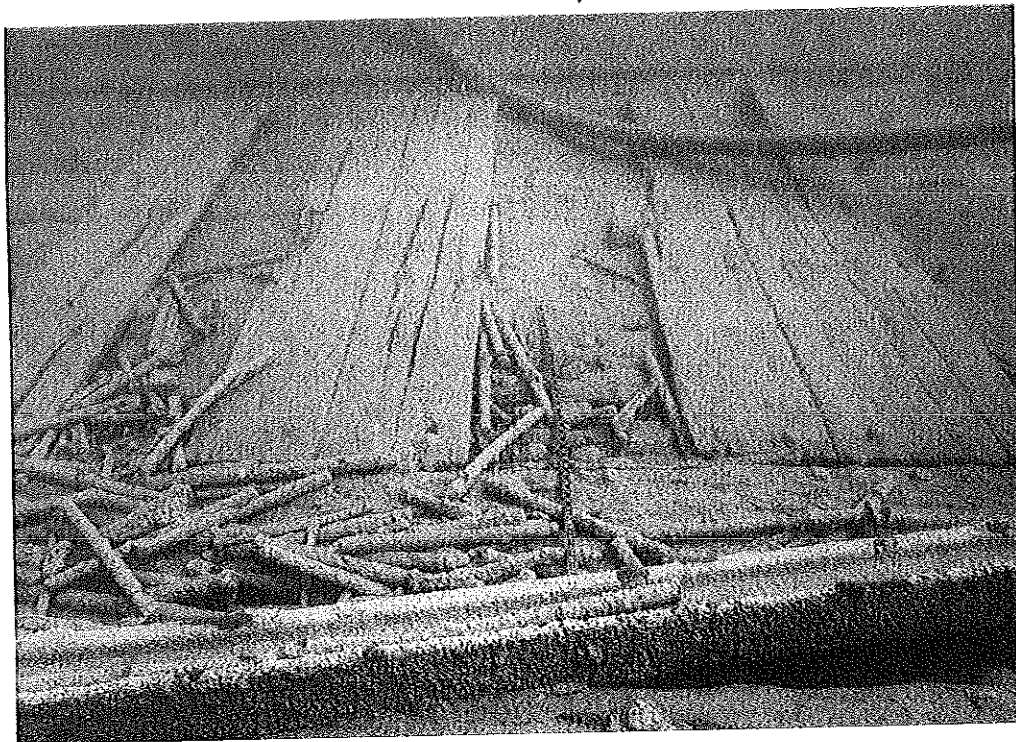
The hull is ceiled with longitudinal ceiling varying from 6 1/2" to 14" wide by 5" thick at the bilges and 2 3/4" thick above the turn of the bilge. It is fastened with 7/8" diameter iron drift pins and 2" diameter clinch rings. Portions of surviving athwartships ceiling (Figure 26) were found in the stern measuring 14 1/2" wide by 3/4" thick, running across the flat of the floors from the keelsons to the turn of the bilge. This appeared to be of a softer wood (possibly pine) and was apparently a sacrificial layer of easily-replaced planking over the bilge ceiling as protection against heavy cargoes such as coal and iron ore. Exterior planking varies from 8" to 9" in width, measures 3 1/2" in thickness, and is caulked with oakum, remnants of which may still be found in the planking on the port quarter.

Figure 26. *Athwartships bilge ceiling, port side.*

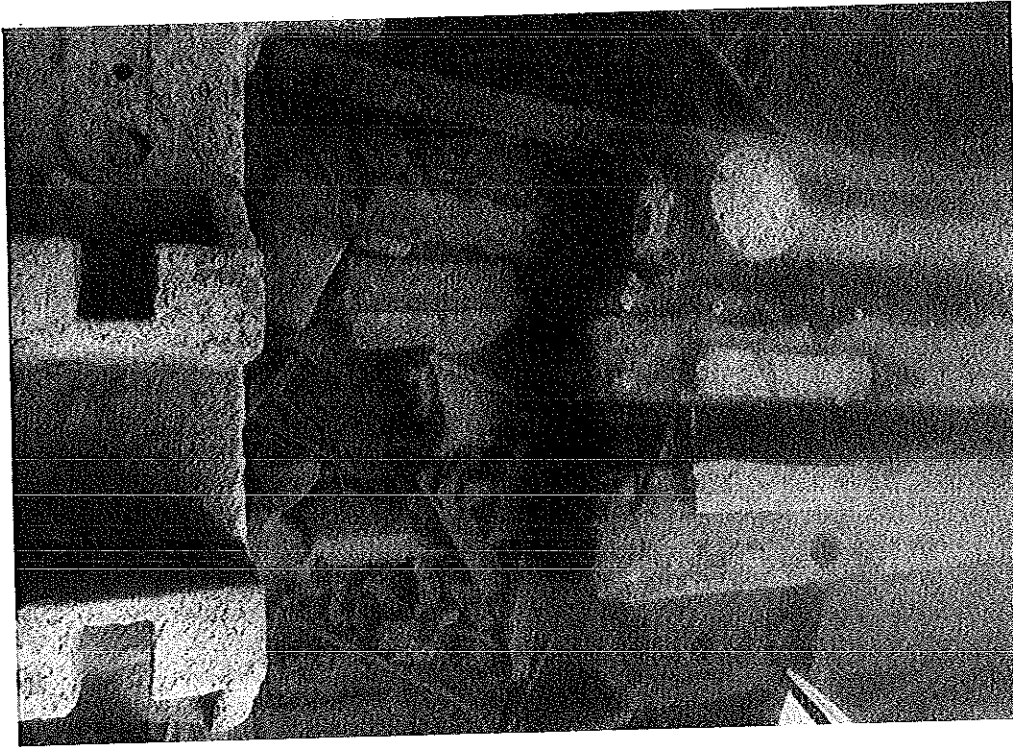
Figure 27. *Forward engine mount (foreground), bilge pump pipe at left, keelsons and "trunk" for stanchions visible rear center.*
