# Survey of Submerged Cultural Resources in Northern Door County

1988 FIELD SEASON REPORT

DAVID J. COOPER ◦ UNDERWATER ARCHEOLOGY  
PROGRAM ◦ DIVISION OF HISTORIC PRESERVATION  
◦ STATE HISTORICAL SOCIETY OF WISCONSIN ◦

J U N E 1 9 8 9

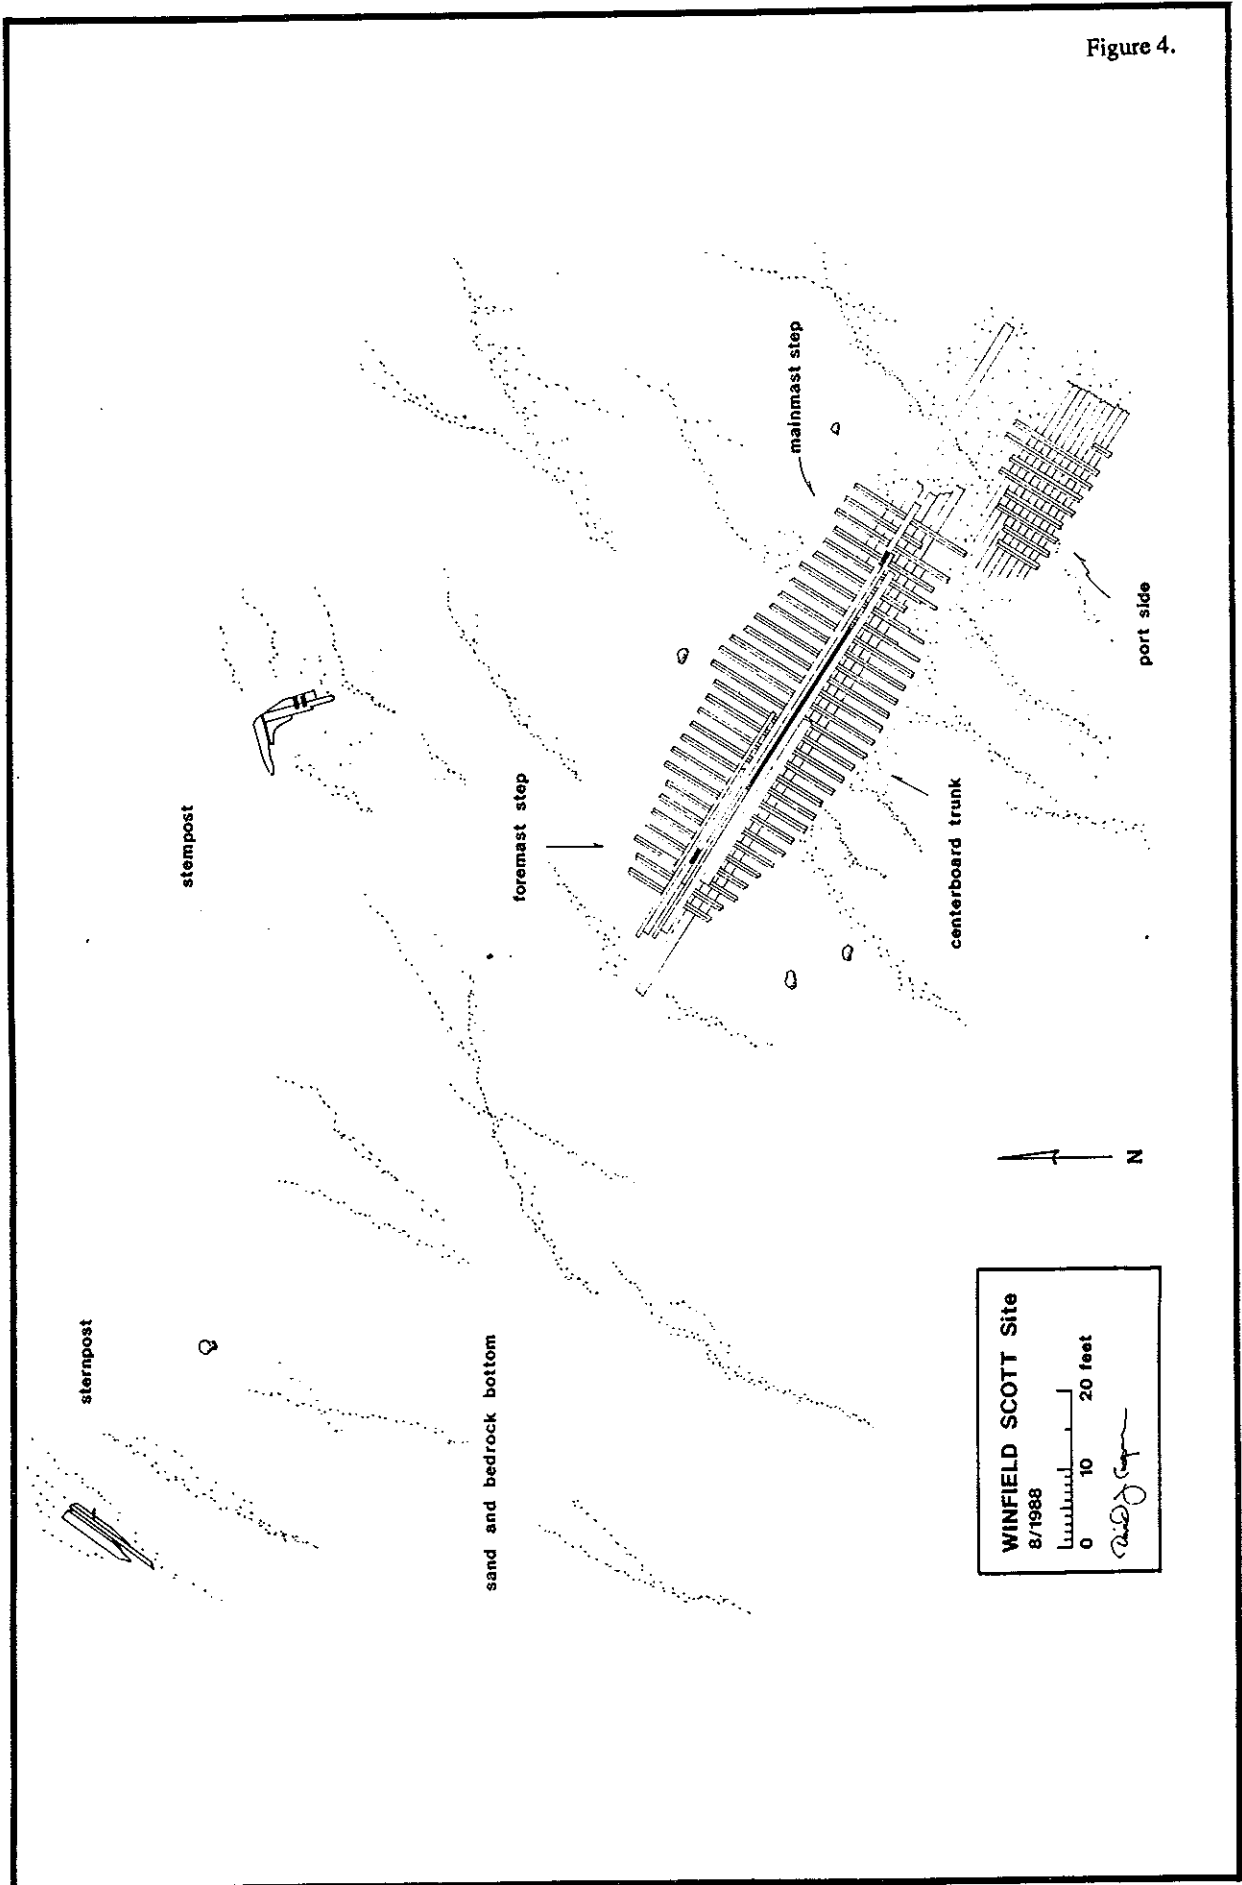
Figure 4.

What is believed to be the wreck of the WINFIELD SCOTT lies in the shallows between Hog Island and Washington Island, directly off East Side park, and is shown on National Ocean Service chart 14909 as a wreck obstruction. The site was relocated in August 1988 using LORAN-C coordinates taken from chart 14909 and visual survey by divers. The main section of the wreck lies in seven feet of water (1988 lake level), on a bottom of sand and bedrock. What is believed to be the bow (based on the location of the two mast steps) is facing inshore (northwest). The disarticulated stempost and bow deadwood is located due north of the main wreck, and the sternpost is located to the northwest. A section of the port side and stern quarter was found just off the site to the south. An additional piece of wreckage was located approximately 100 yards west (inshore) of the wreck (Figure 4).

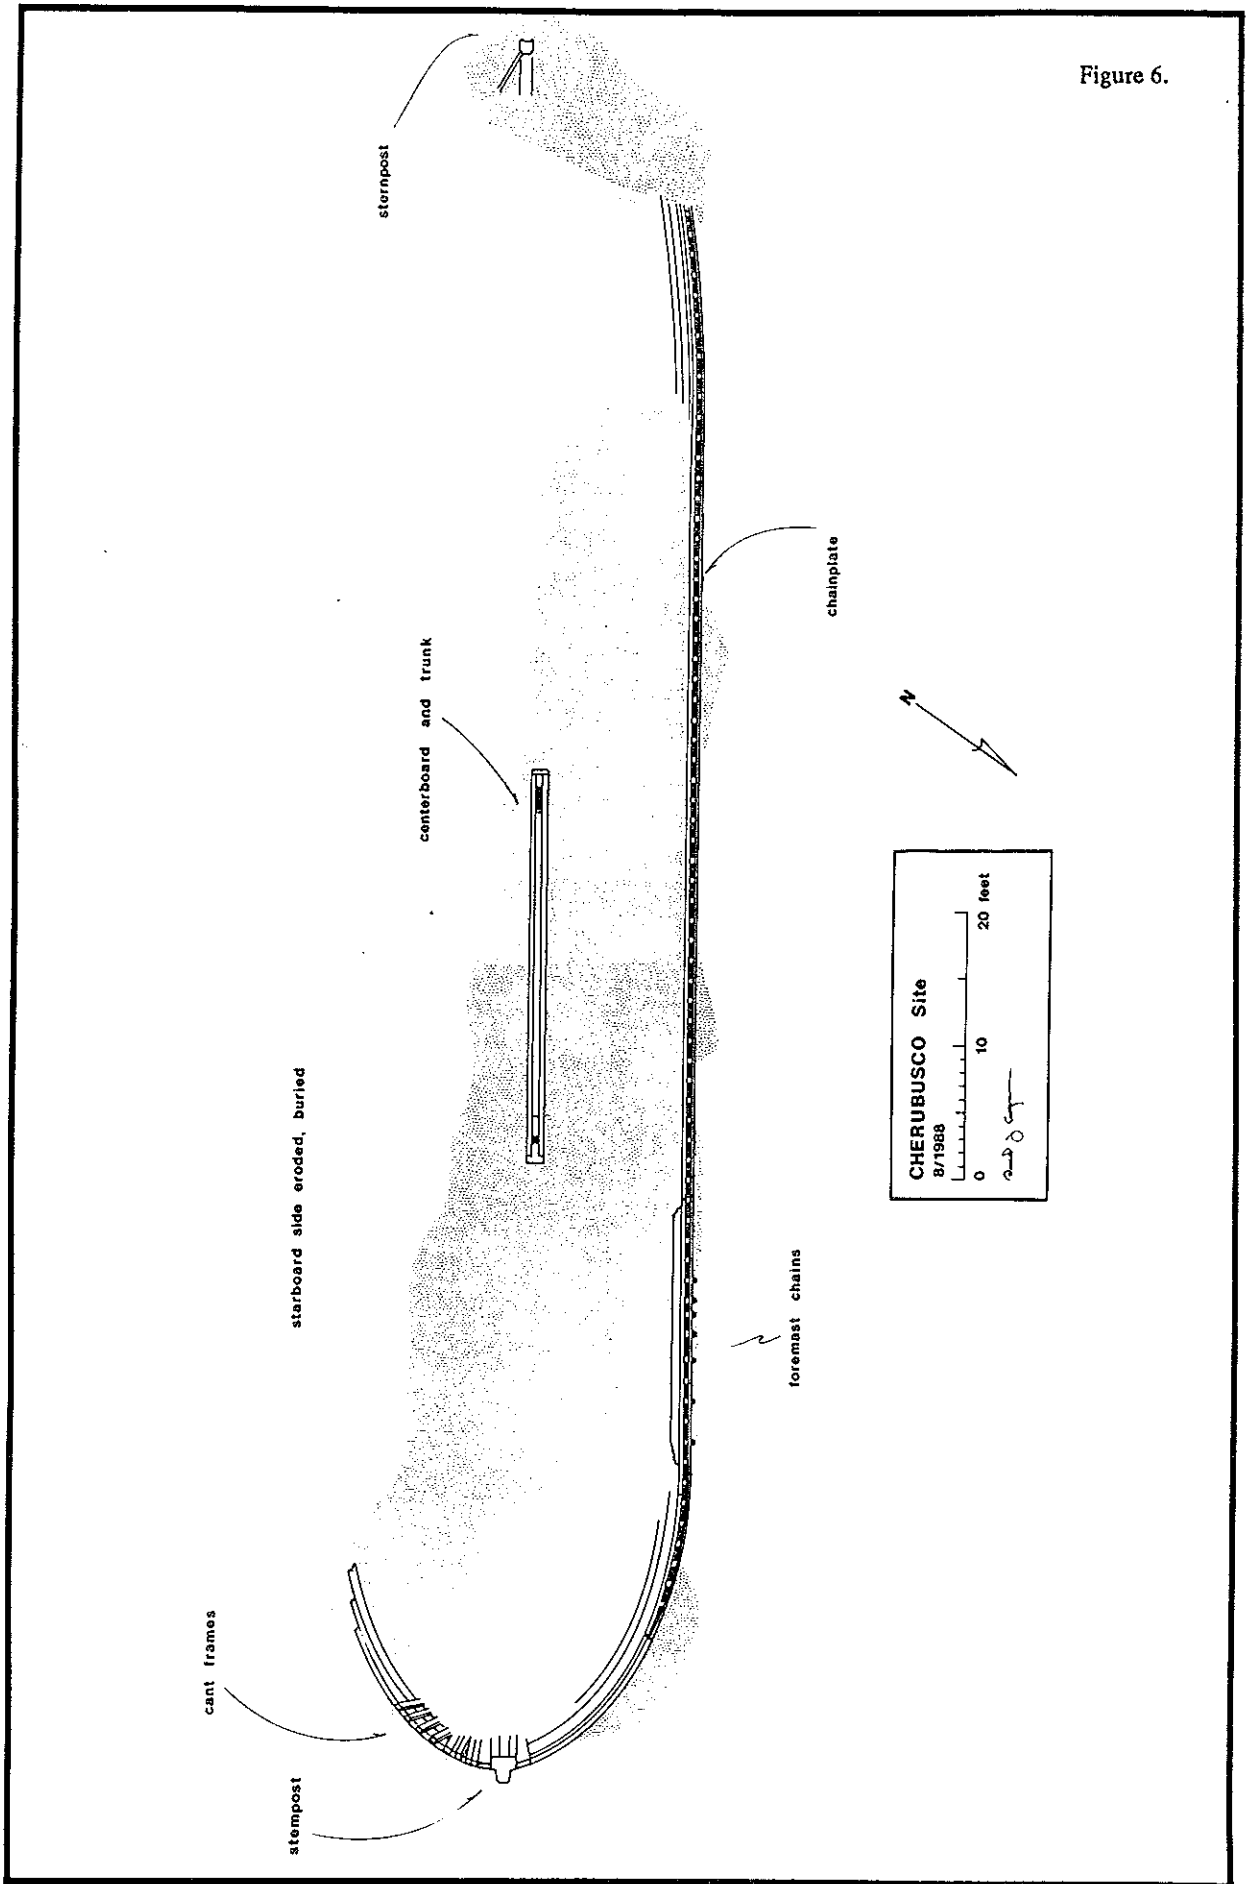
Figure 6.

What is reportedly the wreck of the CHERUBUSCO lies in the middle of North Bay in approximately eight feet of water, and is shown as a wreck obstruction on National Ocean Service chart 14909. The site was relocated using LORAN-C coordinates interpolated from the chart, and by visual survey. It is situated bow to the southeast bearing approximately 145 degrees magnetic. The hull is largely intact, the stempost, bow, centerboard trunk, and sternpost surviving up to their original height (Figure 6). The port side is somewhat intact, particularly in the area of the forechains, where the through-fastenings for the chainplates have reinforced the hull structure, preventing its breaking away. The starboard side has broken away, and most of the starboard side and stern of the vessel is buried under overburden. The overburden on site consists of a light, silty sand which stirs up rather easily. The site is also heavily choked with summer aquatic weeds, which limits visibility, and hinders survey work.

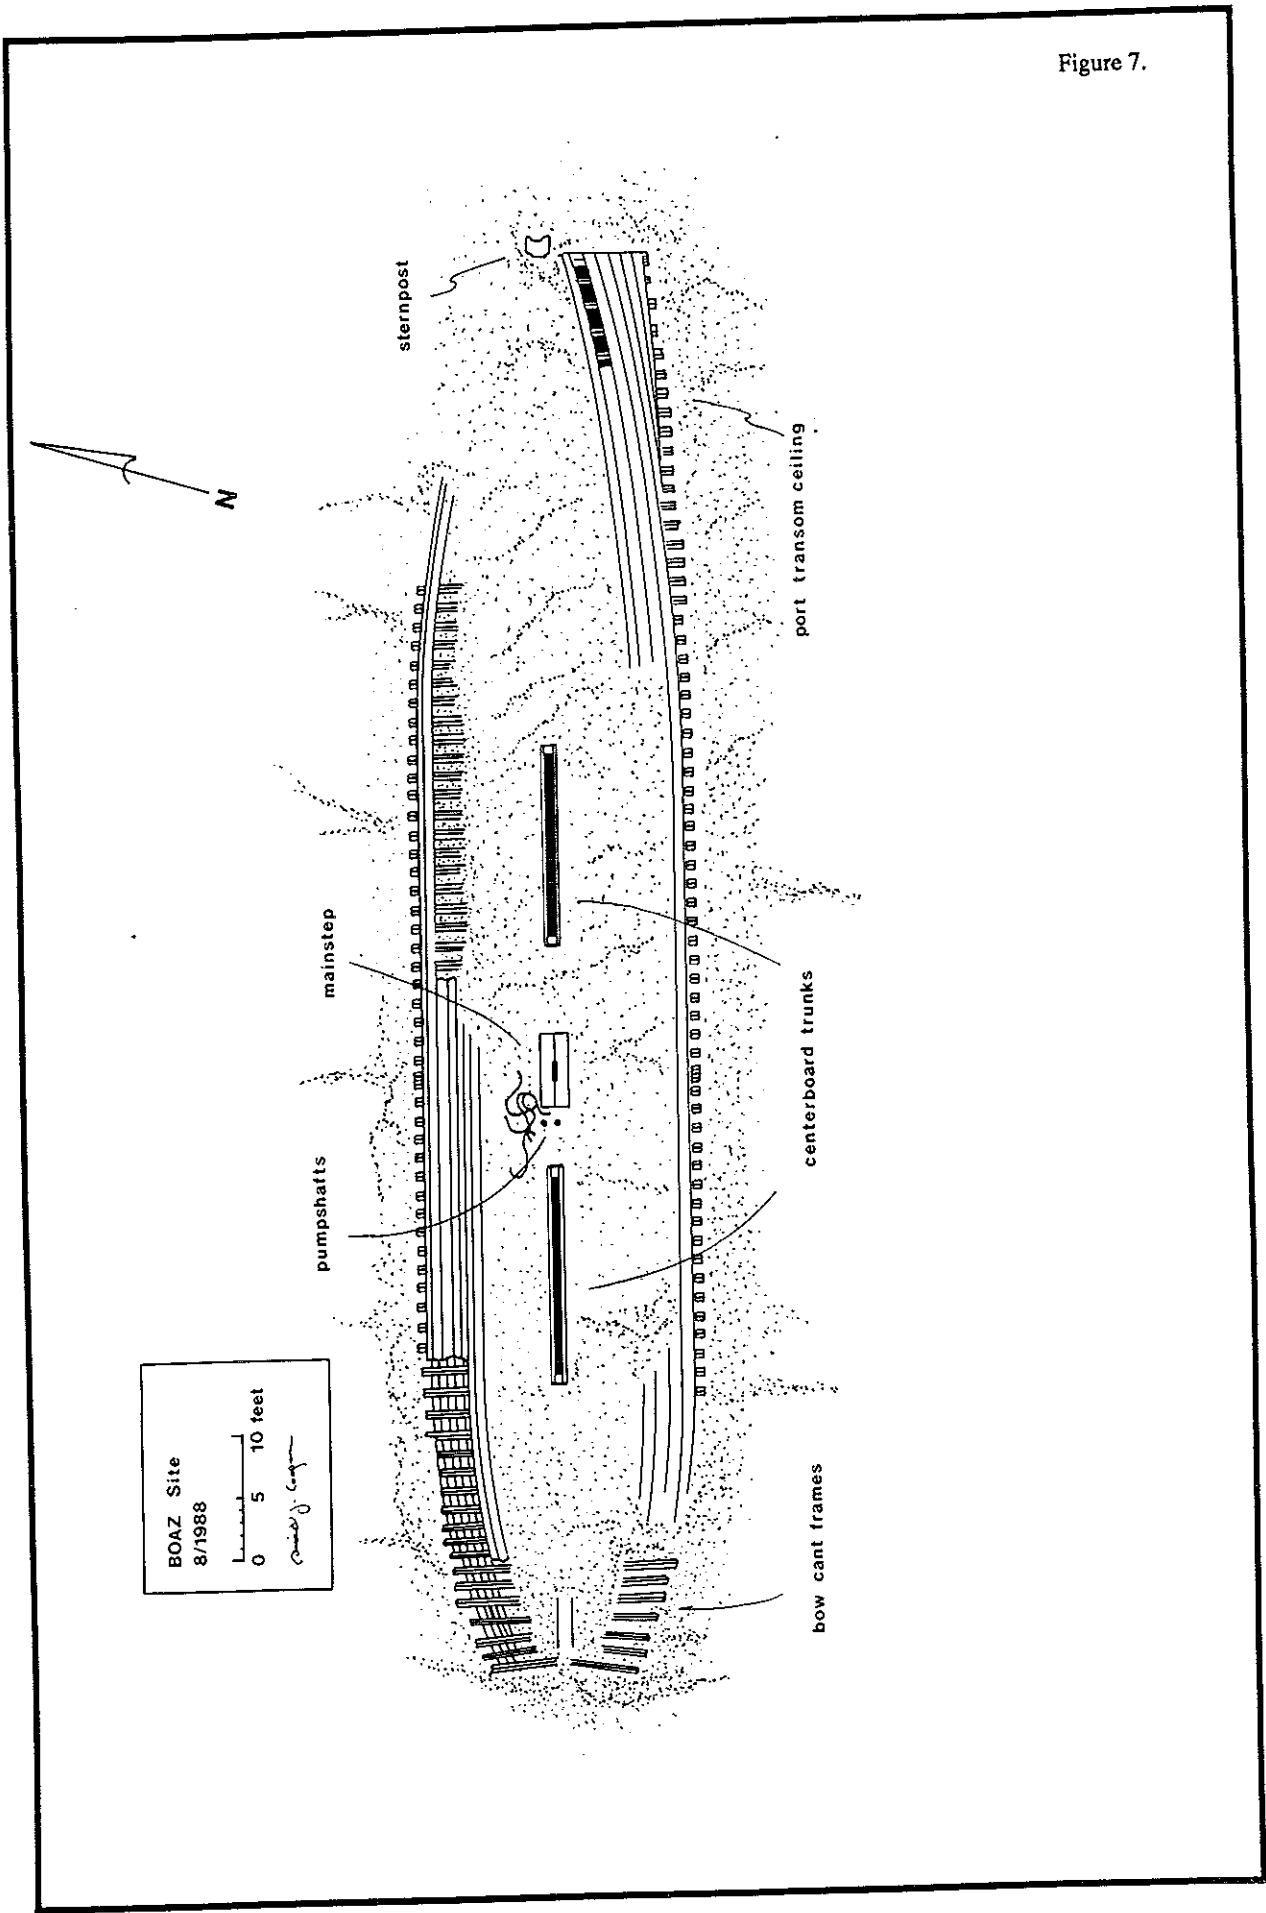
Figure 7.

The vessel has a somewhat unusual tandem arrangement of twin centerboard trunks, placed fore and aft, with a rectangular mainmast step and twin pumpshafts in between. The placement of the trunks in line with the step and pumpshafts implies that this is a through-the-keel centerboard design, but test excavations around the trunks would be needed to confirm this. The placement of the maststep is consistent with this being a three-masted vessel, but (unfortunately) it cannot be found reported that the BOAZ was a tandem-centerboard schooner. The vessel's beam between the trunks is 22', and

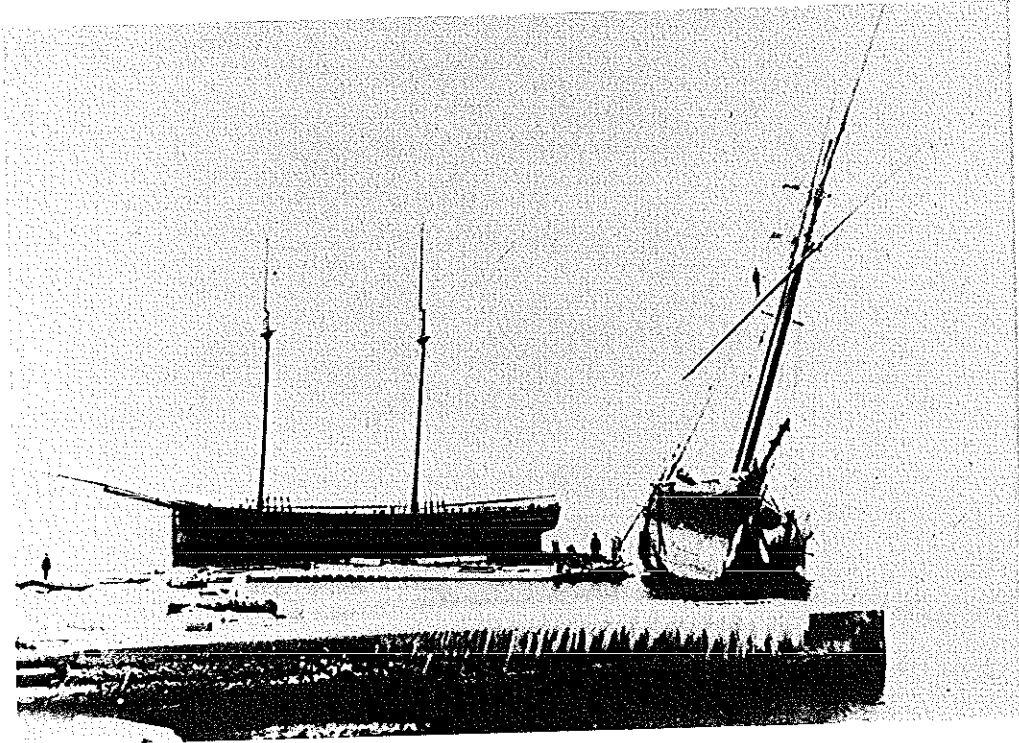
Figure 8. *A.P. NICHOLS (right), J.E. Gilmore (left), and remains of scow-schooner FOREST (between dock in foreground and GILMORE) ashore on Pilot Island, October 1892.*

With strong evidence identifying section H as being part of the NICHOLS, and with near identical construction attributes between H and C, it appears that the remains of the NICHOLS were pushed north off Pilot Island's southeast reef in the direction of the lighthouse dock (Figure 8, foreground) at some point prior to February 1894 when the NICHOLS was reported to have disappeared due to wave and ice action (Door County Advocate 2/10/1894 p.5,c.3). Evidently, the port side and stern were twisted off from the bottom at the turn of the bilge and at a point in the keel thirty-three feet forward of the sternpost. The piece (H) was deposited to the north, followed closely by the bottom (C) which landed atop the side in an inverted position. Adding the 33' of preserved keel and keelson on H with the 106'2" of C indicates that 139'2" of

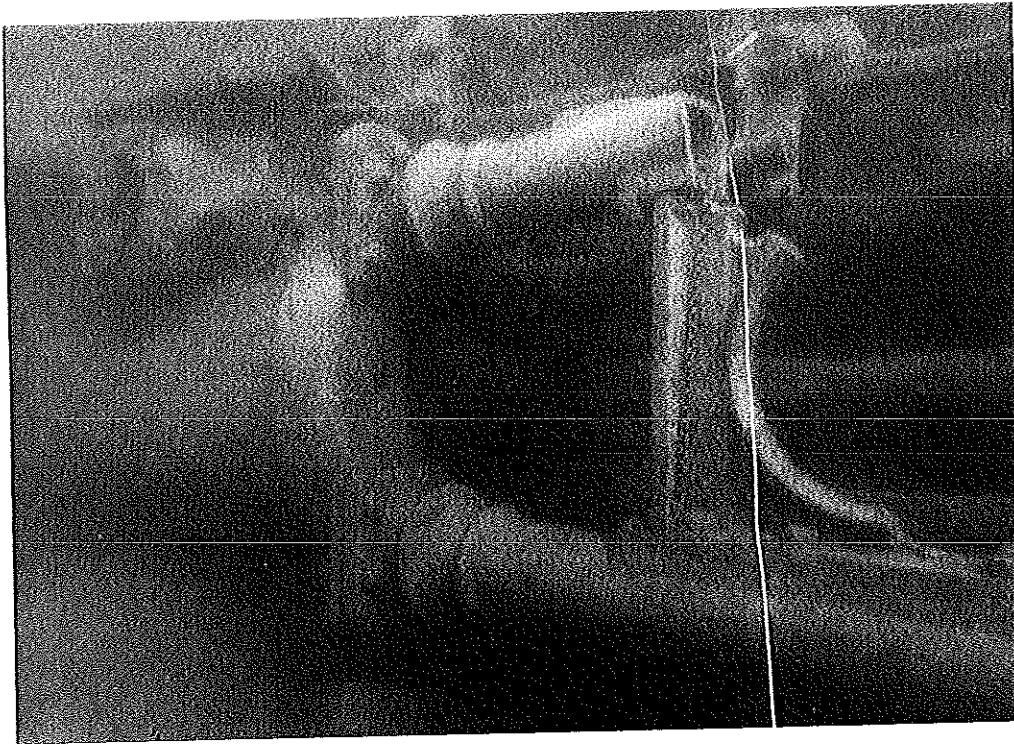
Figure 19. *Steple engine; note Neo-Classical columned framing.*

An interesting aspect of the site is the remains of the steeple compound steam engine and associated machinery (Figures 19 and 20). The steeple engine lies heeled over to the starboard side of the wreck, with the engine area occupied by broken remains of iron engine framing, pipes, and other debris. The engine framing is in the form of four Neo-Classical columns supporting the steepled cylinders. Notable in the engine debris is the remains of the air pump, as well as a condenser. Sheet iron which probably lined the boiler area of the engine room can also be found. The floor frames in the engineering spaces are

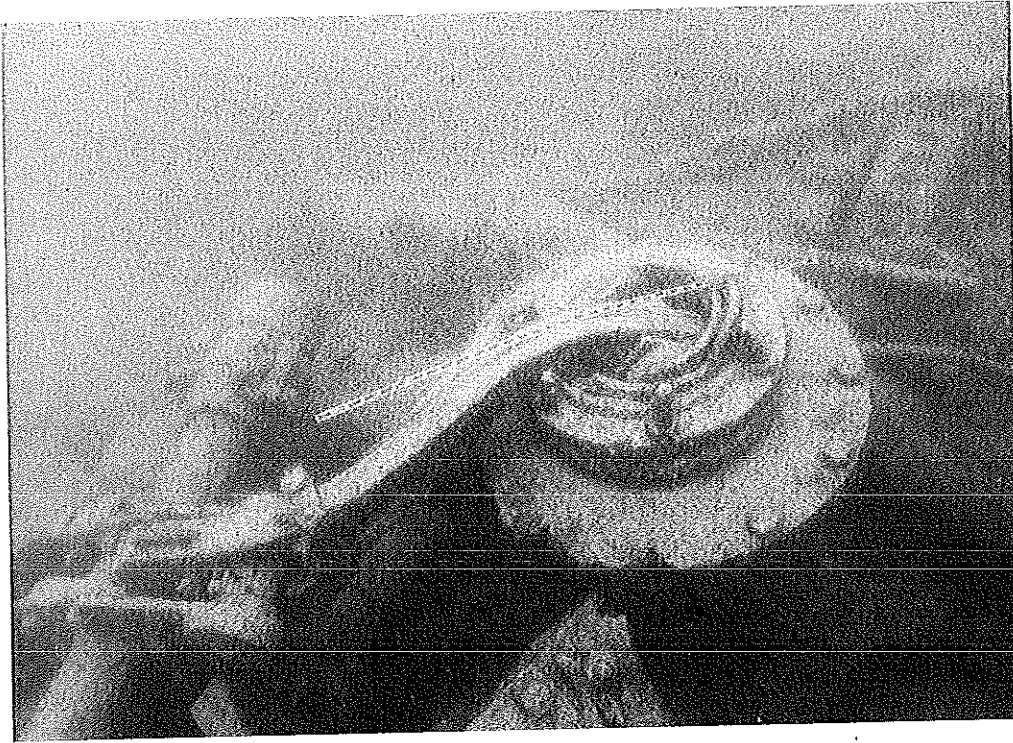
Figure 20. *HACKETT* air pump for steeple engine.

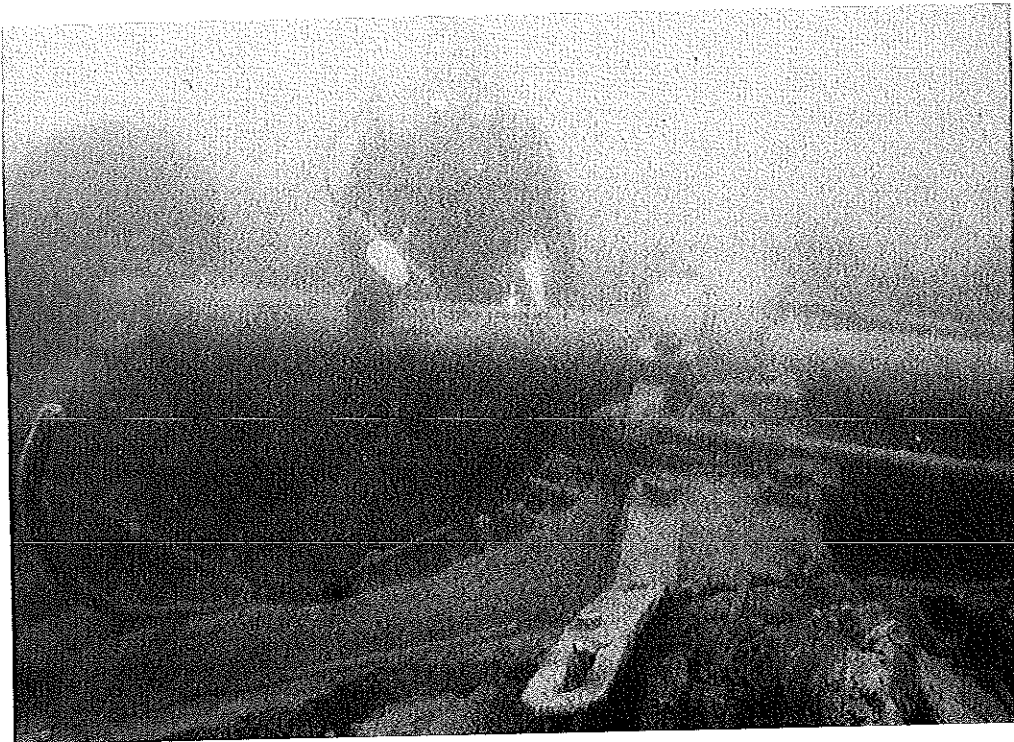
Figure 21. *Diver David Anderson inspects propeller shaft, thrust bearing and braces, and flywheel.*

The surviving propeller shaft assembly (Figure 21) includes a cam, flywheel and bearing, thrust bearing, and a shaft coupling. The thrust bearing is mounted on a pillow block reinforced with 1 1/2" diameter iron tie rods fastened to plates bolted to the hull. The propeller shaft is 9" in diameter. The propeller itself, originally four-bladed, has only one blade extant measuring 4'3" in length. The other three blades are broken off close to the hub, possibly by salvage work, or possibly from striking the shoal during the vessel's stranding.

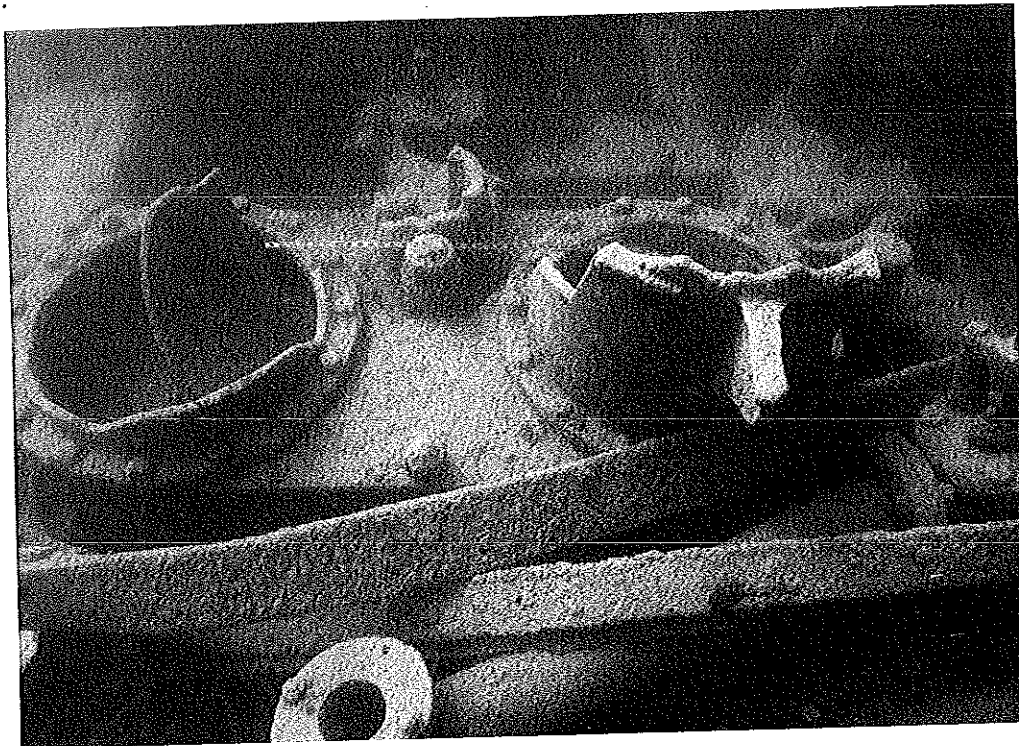
The vicinity of the engine mount is literally choked with engine debris, including sheet metal, fragments of the engine, piping, fasteners, and iron cross-bracing. The mount consists of an iron base fastened to wooden supports running athwartships (Figure 27). The broken bases of the fore and aft cylinders may be seen to the port of the engine mount (Figure 28). A ten foot long section of bilge pump pipe and strainer for a steam-powered pump is located to the port side of the stern keelsons, running down into the bilge through the ceiling. The pipe measures 8" in outer diameter.

Figure 28. *Fore and aft cylinders, viewed from port side.*
